SUBJECT: A construction carpenter was killed when struck by the bucket of a backhoe.

SUMMARY
California FACE Report #01CA013

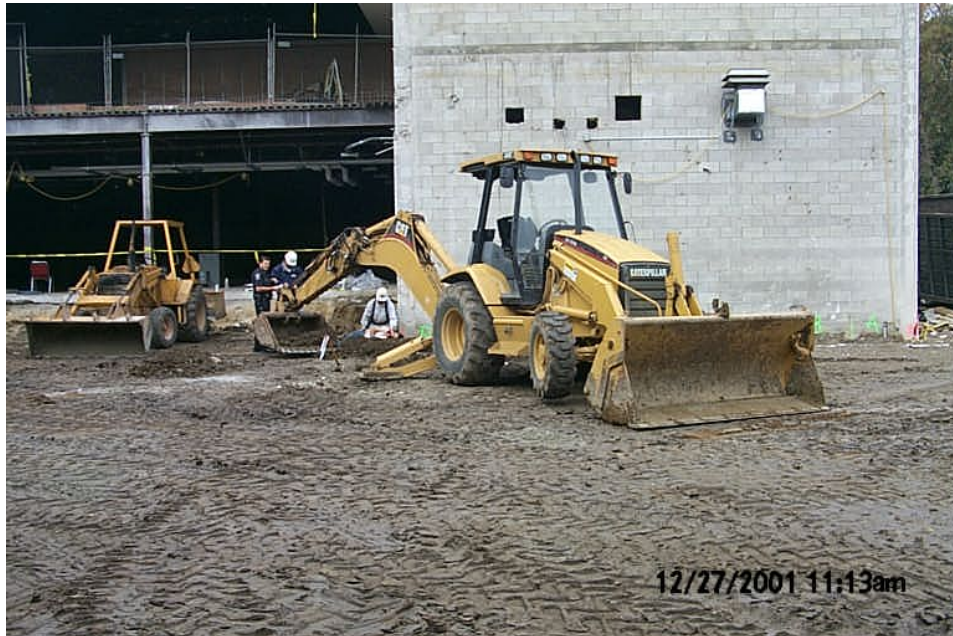
01CA013
Exhibit #1

View of the incident scene showing the backhoe and the work area involved.

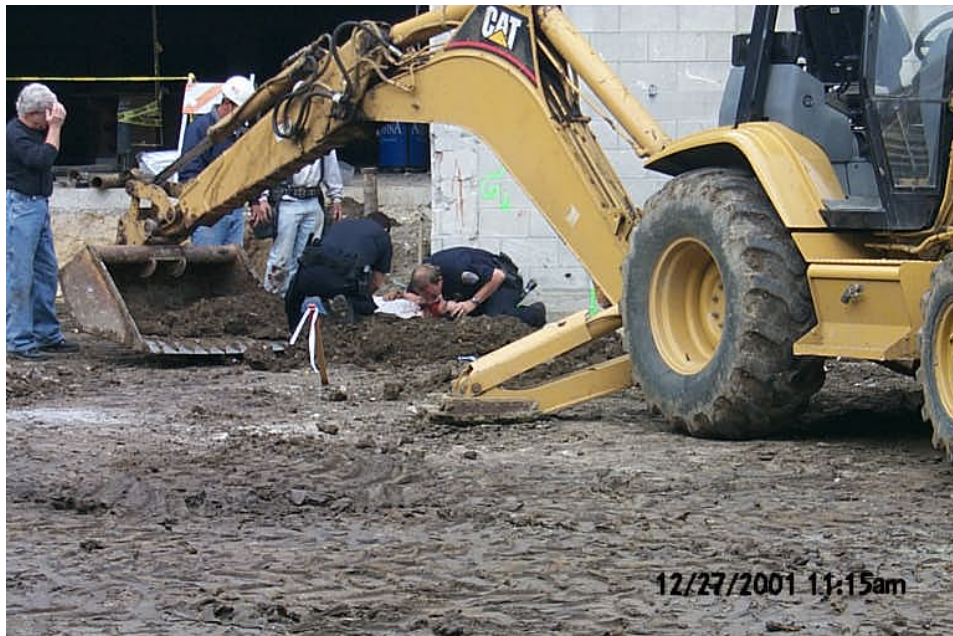
01CA013
Exhibit #2

A closer view of the backhoe bucket and paramedics performing CPR on the victim before transporting to the hospital.

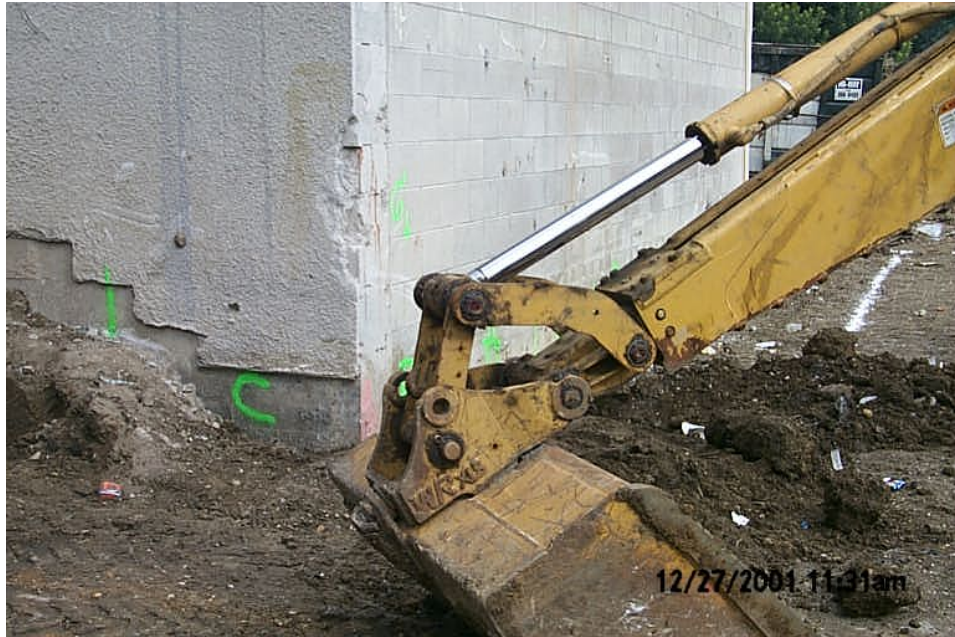
01CA013
Exhibit #3

A view of the backhoe bucket and the wall with marking used for grading.
